# Anomalous Metals in Electrified Vacuum

## Abstract

Independent analysis of Quantum Rabbit (QR) vacuum arc test samples from an experiment conducted on Sept. 27, 2011 revealed the anomalous appearance of potassium (K) and gold (Au). These anomalies appeared in a prior QR vacuum arc test and raise the possibility of low energy transmutation.

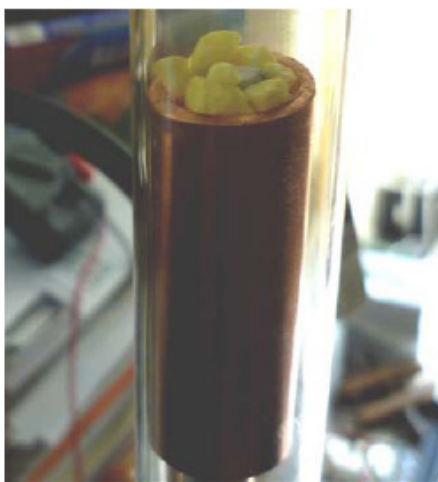
**Figure 1.** Sulfur and lithium atop the anode recess.

The first modification was the creation of a small recess at the center of the anode. The recess facilitated a more secure placement of test material in the tube. The recess helped confine the test material to the reaction zone. As was the case in 2009, a lead insert was placed in the center of the copper anode. The lead insert consisted of a lead slug approximately 0.25-inch diameter pressed into a 0.25-inch by 0.25-inch drilled hole. One piece of lithium was centrally placed atop the lead insert. The lithium was surrounded by sulfur pieces (Fig. 1).

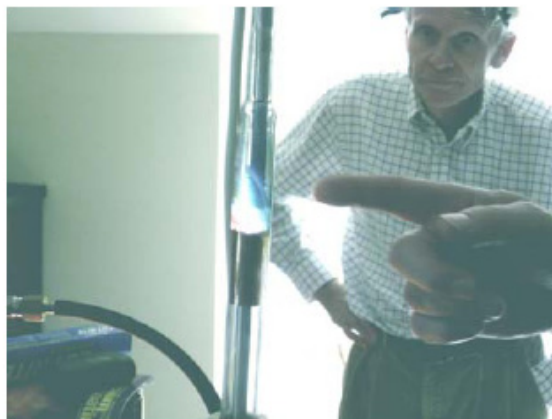
**Figure 2.** Blue–green discharge in vacuum tube.

The test proceeded in real time as follows (keep in mind that the data points are approximate.) The tube was pumped down to vacuum. Neon was admitted at the start to 2 torr. At 1 min in, the torr reading was 3.0, while power supply readings measured 53 V and 6.95 A. The inside of the tube was glowing red-purple, with what appeared to be the color of neon plasma. At about 2 min, the readings were as follows: 3.0 torr, 70 V, and 5.63 A. Intense heat was generated at this point; so that the test materials appeared to be melting. Oxygen was admitted between minute 3 and 4, and the torr reading went up to approximately 8.28. Following the oxygen fill, the test material began glowing a ruby red, the characteristic color of lithium plasma. At around 6 min, there was concern that the tube had failed. Power was disconnected. Thirty seconds later it was decided that the tube was still viable, and the decision was made to admit fresh oxygen and fire up the tube once again. At this point the tube began glowing blue–green (Fig. 2).
