# LENR Anomalies in Pd–H<sub>2</sub> Systems Submitted to Laser Stimulation

Ubaldo Mastromatteo\*

*A.R.G.A.L. Via S. Stefano, 27 – 20010 Bareggio (MI), Italy*

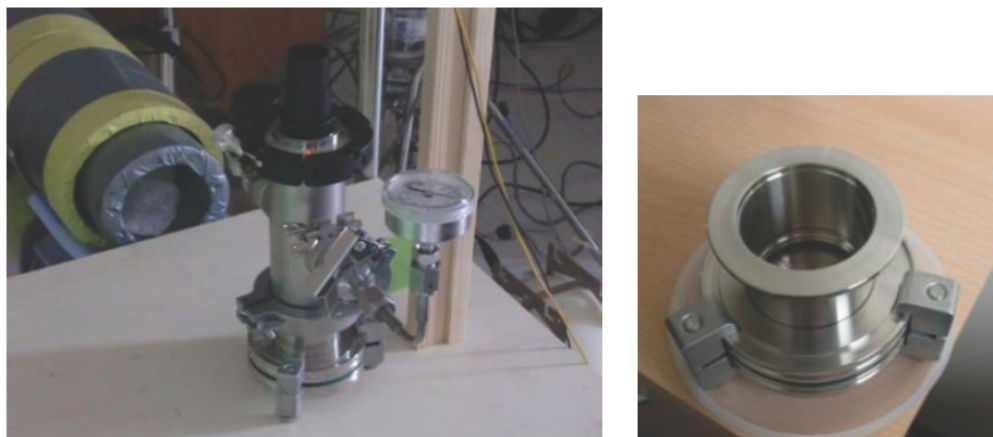
**Figure 7.** Photos of the reactor and the bottom part where the sample with the palladium film will be placed.

Figure 7 shows the reactor. The sample was an oxidized silicon chip on which it was deposited a layer of palladium 250 nm thick. The size of the chip is: width 1 mm, length 28 mm. See Fig. 8.
